# **Contamination and Decontamination of a Light Armoured Vehicle**

*Work performed under the Swedish-Canadian accord*

TECHNICAL MEMORANDUM

DRDC Ottawa TM 2002-107

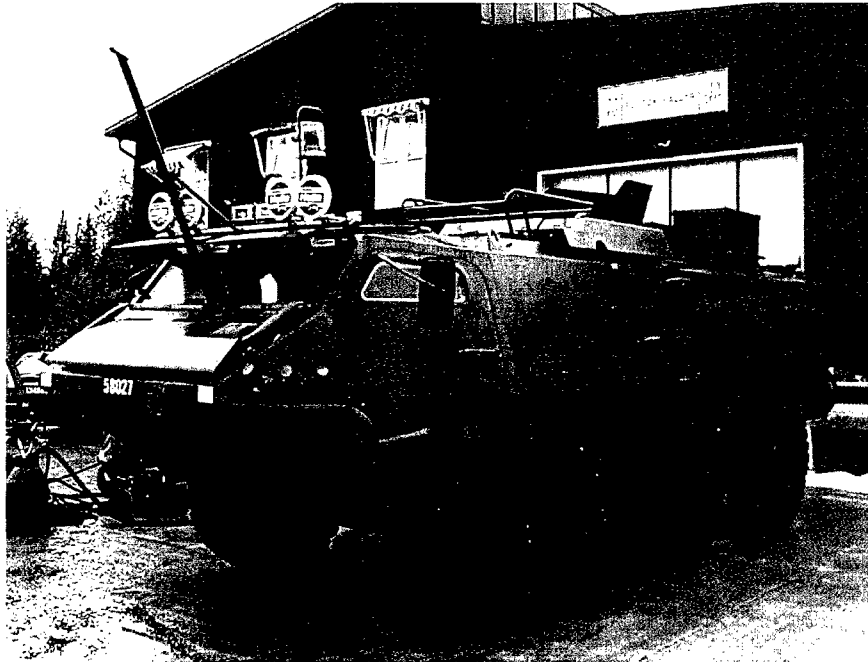
*Figure 3. The SISU XA-180 Light Armoured Vehicle.*

The test vehicle for the trials was a SISU XA-180 Light Armoured Vehicle, pictured in Figure 3. The XA-180 drove around the contaminated track 10 times, and then returned to the measurement area. The contamination pattern was then characterized with the ABP-100 alpha-beta probe [6] and with swipes. A Swedish team without previous experience of decontaminating the XA-180 then decontaminated the vehicle with a high-pressure water spray. This is the same system developed by DRDC Suffield, but without the CASCAD decontaminant foam [7]. Following this procedure, the remaining contamination on the vehicle was re-measured. The XA-180 was then driven out onto the track again for 10 laps, before returning to the measurement area. As before, the contamination pattern was characterized. A team from VLN Advanced Technologies Inc. then attempted to decontaminate the vehicle with their forced pulsed water jet system. The remaining contamination on the vehicle was again re-measured. The VLN water jet system is capable of running at extremely high pressures, however for this work pressures were constrained so that the paint on the XA-180 would not be removed. That being said, paint was removed from the vehicle wherever it was the least bit loose.
